# CLASSICAL REGLOSS: Restoration of a 1961 Power Cat 18DC

BY BRIAN LAWSON, HUDSON RIVER CHAPTER

## RESTORATION OF A 1961 POWER CAT 18DC: PART 2

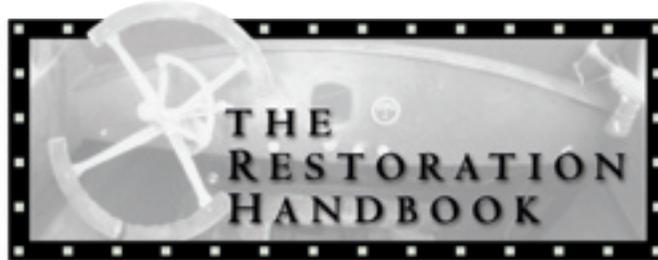
Next I tackled the outside. Moss hates bleach. First, I sprayed the sides with Tilex® (2.5% sodium hypochlorite, or half strength bleach), letting it sit for a few minutes, and then hit it with a scrub brush and plenty of water. Washing the transom and the starboard side reminded me of the glass repairs that lay ahead. This boat had MANY up and down deep scratches in the gelcoat where it rose and fell during the storm. There were several holes in the side, and the transom

on the starboard side was broken open about two-thirds of the way up from the bottom. The port side on the other hand, was nearly perfect. The yellow top looked the worst, but after a bleach treatment, the beautiful butter yellow color of the gelcoat, generally in good condition, was revealed. Washing down the starboard side of the top showed me how much

damage had occurred to this area, too. The gunwale was severely damaged, and a poor attempt at repairs had to be dealt with. The end of the starboard fin was missing the last six inches, but the port fin was fine.

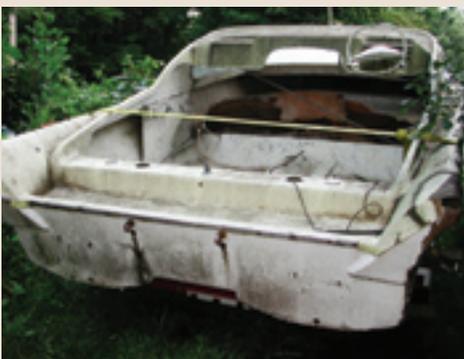
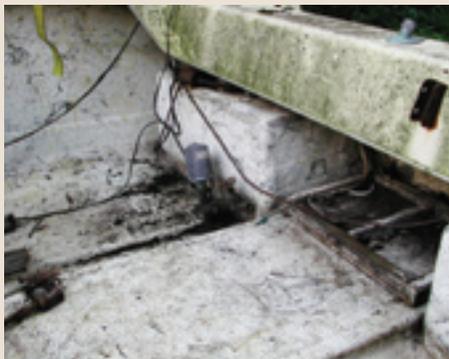
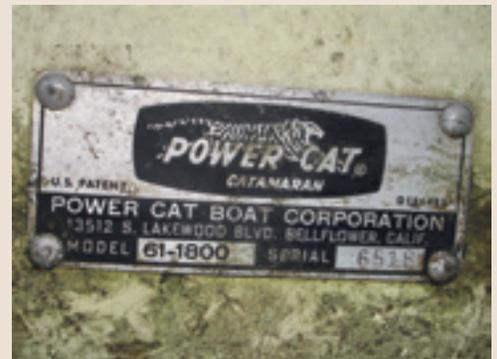
Moss never sleeps...the Power Cat is looking pretty funky after years of neglect during outside storage. View of the shattered transom and missing starboard fin. Molded fiberglass fuel tanks under the splash well—the water pump installed through the floor. After a thorough cleaning, the inside, amazingly, was in near-to-perfect condition. Shot of the manufacturer's plate.

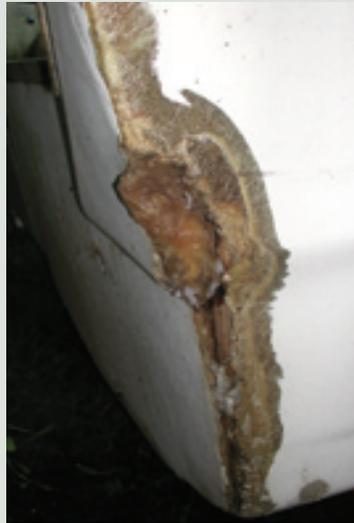
With the fuel tanks out, the boat cleaned, the survey completed and the work list generated, it was time to start deconstructing the boat. The top overlaps the hull by about an inch and a half and is attached using rivets. A rub rail of polished aluminum is installed using T-bolts inserted in a channel molded in its back side. When built, the joint between the top and hull is completely hidden. I began by removing the rub rail T-bolts on the inside of the boat—actually they were all severely corroded and most of them just snapped when I put a wrench on them. With the rub rail off, I drilled out and removed all the rivets. Around the front of the boat on the inside a strip of fiberglass tape had been installed, probably to keep water out when under way. I sharpened the side of a strong scraper and from the outside of the boat inserted this between the hull-deck joint. Using a hammer, I drove the scraper around the front of the boat to cut the fiberglass tape, a total distance of about 16 ft.

Finally, and this is the hard part of top removal, the splash well had to be broken free from the transom. There is no easy way to do this as these boats weren't originally built with the idea that 40 to 50 years hence anyone would be interested in restoring them. For the 18DC I found it easiest to cut off the fiberglass on the top of the transom as this then gave me good access to the plywood resin joint. It takes brute force, saws, and wedges, and more to break an 8-foot-long, 6-inch-wide, fiberglass resin joint. But once broken, the top was free of the bottom.

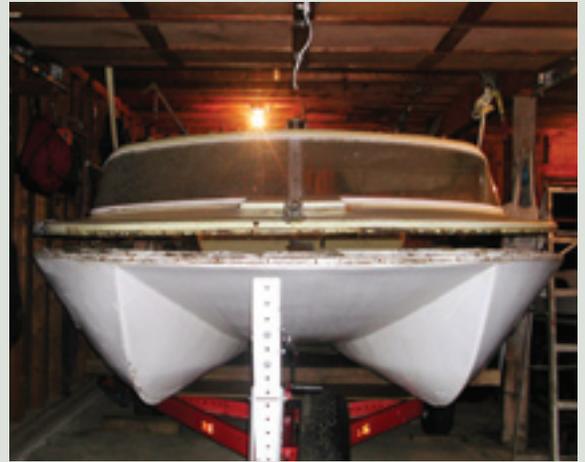
Starboard transom corner; note the transom's core is showing. Popping off the top—just like Tupperware®. Instantly you double the necessary floor space. You need to plan ahead. This boat has a true catamaran hull...and it's huge! Note the come-alongs attached to aerial steel wire. Below: a collage of fiberglass repair materials.

The first job I tackled was to repair the split transom corner. I began by grinding back the gelcoat and fiberglass on the transom and the starboard side to give me a large area to add new structural material and feather the repair to the good fiberglass. I used two layers of heavy MAT cloth saturated with polyester resin. The first MAT down covered the crack and went about halfway over the ground area. The second piece covered the entire first piece and all of the ground area. Care was taken to match the molded shape as closely as possible. The MAT was then sanded level and the entire repair area was covered with Kitty Hair—long strand fiberglass mixed with polyester resin. When hard, the Kitty Hair was sanded smooth. Next I transferred the lines on the port side hull to the starboard side to determine where I was heavy and light in filler. Using various fiberglass fillers I built up areas that needed it and sanded off material where there was too much until I had the starboard measurements

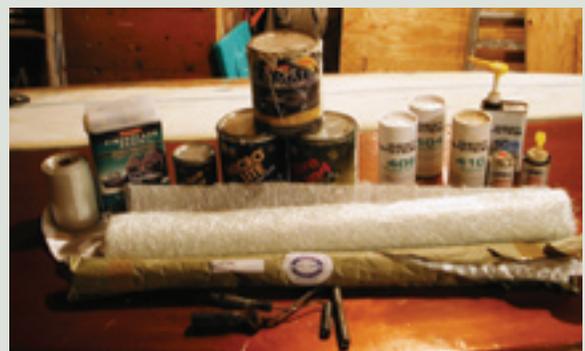
The collage photo shows some of the products one I use in fiberglass repair projects. Next time I'll chronicle fiberglass repairs and finishing of the boat.

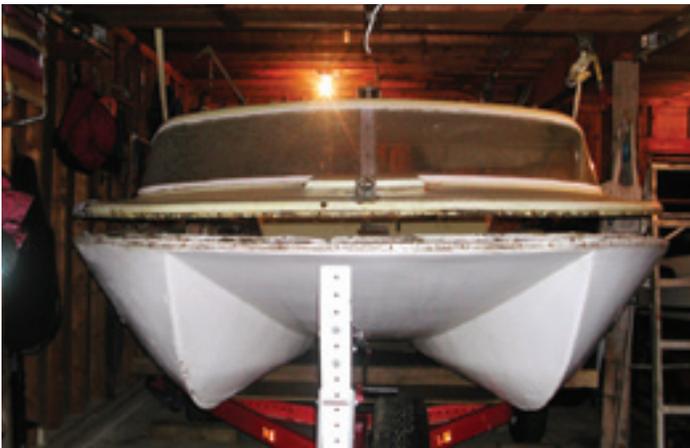
The Power Cat 18DC is a 17-foot-long and 8-foot-wide, tunnel-hull day cruiser with a small cuddy cabin. Part One of this article ended with the boat split in two and the hull rolled over and supported to begin work, while the top was placed on a work rack to support it and work on. The boat was severely damaged in a storm in the 1960s. Major issues when I got the boat (free) included damage to the starboard gunwale, the starboard transom corner was split open the full height exposing the plywood core, there were holes, gashes and scratches on much of the starboard side where the boat rode up and down on a dock, and because the transom core had been exposed to water, rot had started in the core. My plan was to do the repairs to the exterior of the hull first, and then roll the hull back over to replace the transom core. The majority of the top repair was done with the top off the boat.

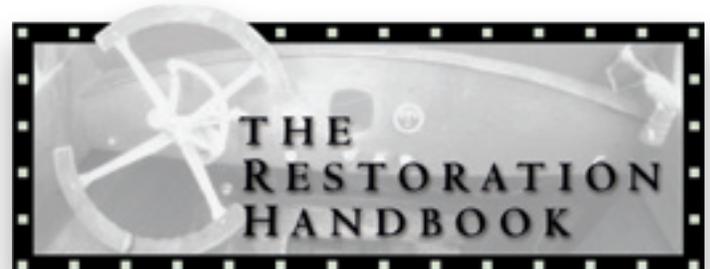
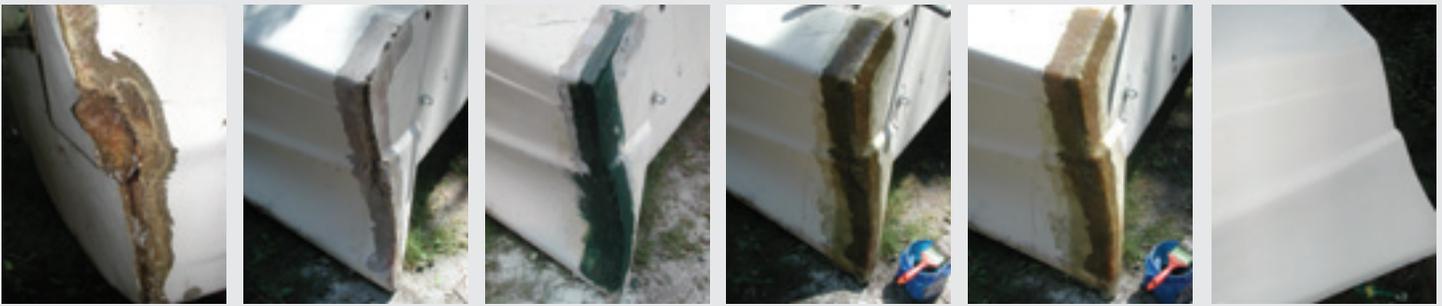
At this point the hull was ready for exterior finish. Options abound here. When originally built the outer finish was 0.030"-0.035" white gelcoat. Some fiberglass restorers would shoot new gelcoat on the hull at this point, and then spend many hours wet sanding and buffing. I don't spray finishes because my shop is not set up for it. I can lay down paint and have it look nearly as good as sprayed gelcoat. Although technically more original, spraying a new gelcoat layer I find no different than applying a layer of paint whether sprayed or painted. They are all new finishes not original to the boat,

and therefore for ACBS judging I would call it a restoration, not an original hull. To be original I feel the original gelcoat must be the outermost finish. I have found Interlux VC Performance Epoxy to be the wonder paint for white hulls. Performance Epoxy is a two-part epoxy paint that is incredibly hard. The paint can take season after season in the water. When wet sanded and buffed out it looks as good as gelcoat. I painted the hull with four coats of Interlux VC Performance Epoxy, then wet sanded it.

The hull was lifted using an aerial steel wire strung between my shop and a large tree and pulled tight with a come along. From the steel wire I connected two come alongs rigged in an X to transom rings. A motor hoist was connected to the bow eye to let the bow rotate as the hull rolled. The hull was lifted, upside down, straight up about five feet off the ground. Then one of the come alongs was let off slowly, lowering one side of the transom and rotating the boat in the air as the transom corner dropped. The key is to get the boat vertical (literally) with one side close to the ground, the other pointed to the sky, and then slowly let it settle over its center of gravity as the hull starts to go right side up. Then you again use the come alongs, no longer in an X, but now straight up and down to lower the boat onto a trailer. It sounds easy, but this is a huge job. One person can safely perform this if rigged correctly. Recognize there is no rigidity to the hull at the gunwale without the top on it; you cannot put weight on side of the boat as it could easily be damaged. It needs to roll in air. I rolled the boat this way twice during the restoration. As I said in Part one, this is not for the faint hearted.

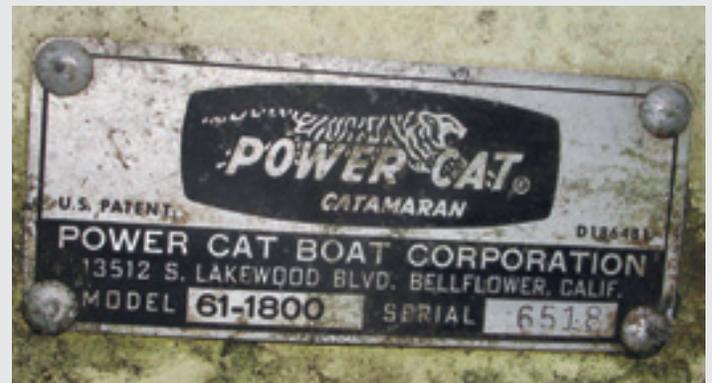
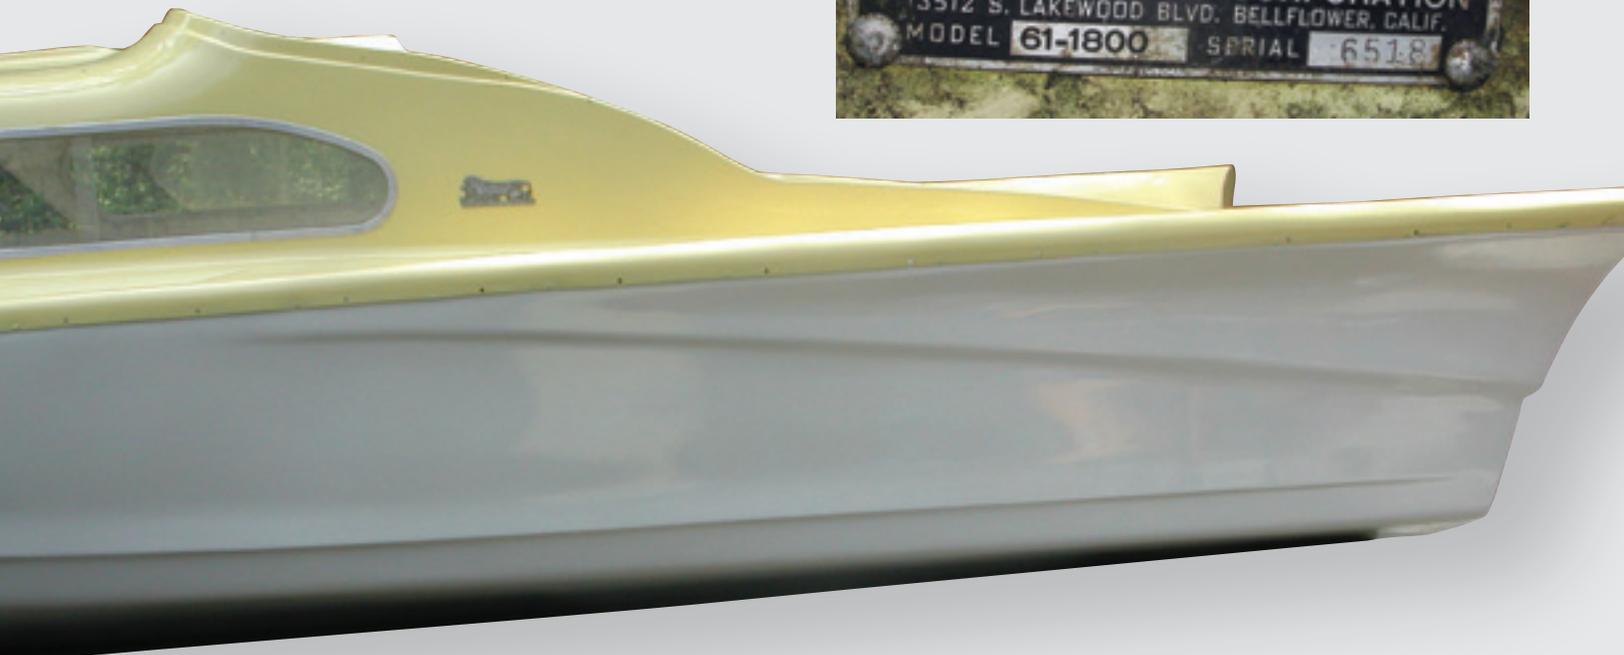
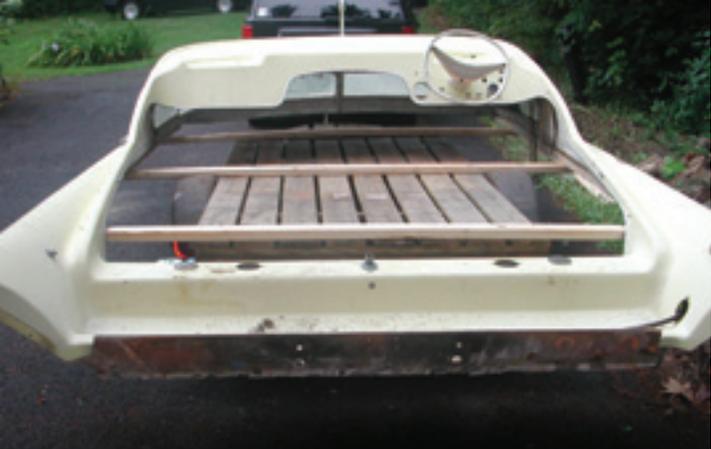
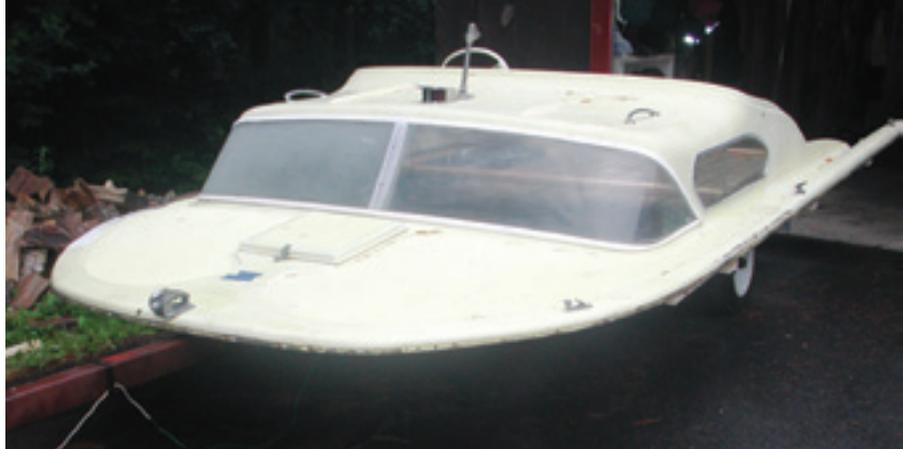
top has to come off the boat to replace the transom core. This was the main reason I split the boat in two. The old transom core, 1 1/2" thick plywood, was removed using a chisel to cut the fiberglass MAT on the inside corners of the transom and the MAT on the bottom of the transom. With these cut I started to separate the outer fiberglass skin from the wood core using chisels and saws, forcing these tools into the space between the plywood and the outer fiberglass skin. It takes some time but eventually working with these tools you can break the bond or cut the material, and you can start to move the wood core and eventually break it free. The plywood I pulled out of the Power Cat was actually not bad, definitely wet, so it needed to be replaced for another fifty-year run.

With the old wood out, the inner skin was cleaned by thoroughly grinding and sanding to remove all wood and glass residue. Next I built a new transom core by sandwiching two pieces of 3/4" plywood together with MAT resin and lots of screws. With the old transom out in one piece I was able to use it to pattern the new core, which I cut, and then fitted to its new home. MAT was cut to fit the inner transom skin, wetted out well with resin and the mating side of the new core was wetted with resin. The new core was then clamped in place with the MAT between it and the fiberglass skin. I also used

a number of screws driven through the outer skin into the core to ensure the skin, MAT and core became like one. You don't want air gaps in this bond as it provides a way for water to wick up. Once the resin hardened, the screws were removed and the holes were filled and sanded smooth. Inside, several strips of MAT with resin were installed from the new core to the sides of the boat and from the floor of the boat up the core to strengthen the bond and make it watertight. Finally an oak cross brace was installed across the transom about 8" from the top of the transom. This provides additional support to carry the twin engines the boat is designed for. I used a piece of 1"x8" oak 8' long. This was glassed into each side of the boat and then screwed and glassed to another piece of oak screwed to the core. The cross brace sits just under the bottom of the splash well and is hidden from view once the top is put back on.

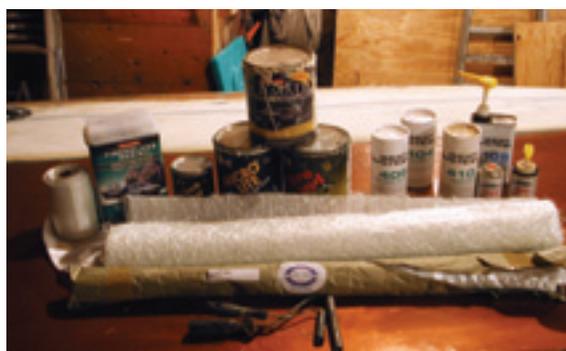
Repairs to the top of the boat were progressing. All hardware had been stripped from it and all the old holes were backed where necessary and filled with filler and sanded. The starboard fin, completely smashed and missing from the boat was rebuilt. I used a piece of flexible Teflon cutting board from the kitchen (thanks to my wife!) to make the form for installing new MAT and cloth on the end of the fin to rebuild it and tie it to the rest of the boat. The cutting board is very flexible but sturdy and was able to take the correct curve coming out the back of the remaining fin. I then laid down MAT

and resin on the cutting board, having ground down the adjacent good glass to give it a place to bite. When hard, the mold was removed as resin won't stick to it. More MAT, Kitty Hair, and finally filler was used to build up the fin and shape it. The starboard gunwale repair that had been done previously was largely removed. The entire area was ground down and then rebuilt with MAT and resin, followed again by Kitty Hair and filler as needed.
