Volume 19, Number 1

# CLASSICAL REGLOSS: Restoration of a 1961 Power Cat 18DC

BY BRIAN LAWSON, HUDSON RIVER CHAPTER

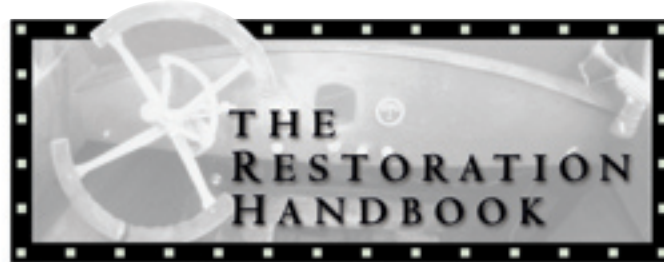
Next I tackled the outside. Moss hates bleach. First, I sprayed the sides with Tilex® (2.5% sodium hypochlorite, or half strength bleach), letting it sit for a few minutes, and then hit it with a scrub brush and plenty of water. Washing the transom and the starboard side reminded me of the glass repairs that lay ahead. This boat had MANY up and down deep scratches in the gelcoat where it rose and fell during the storm. There were several holes in the side, and the transom

on the starboard side was broken open about two-thirds of the way up from the bottom. The port side on the other hand, was nearly perfect. The yellow top looked the worst, but after a bleach treatment, the beautiful butter yellow color of the gelcoat, generally in good condition, was revealed. Washing down the starboard side of the top showed me how much

damage had occurred to this area, too. The gunwale was severely damaged, and a poor attempt at repairs had to be dealt with. The end of the starboard fin was missing the last six inches, but the port fin was fine.

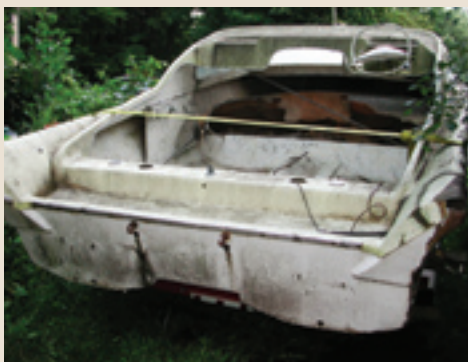
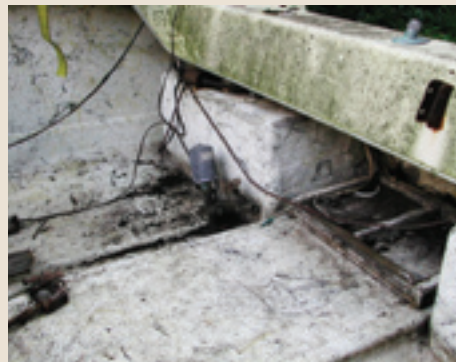
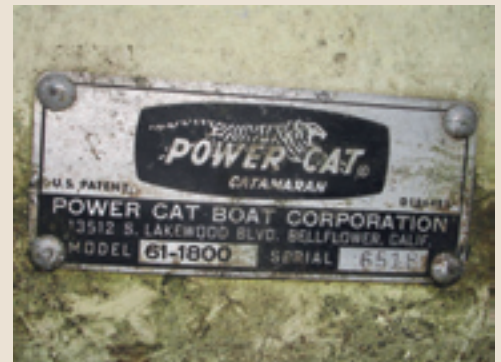
Moss never sleeps...the Power Cat is looking pretty funky after years of neglect during outside storage. View of the shattered transom and missing starboard fin. Molded fiberglass fuel tanks under the splash well—the water pump installed through the floor. After a thorough cleaning, the inside, amazingly, was in near-to-perfect condition. Shot of the manufacturer's plate.

Power Cat Boats tried building fiberglass fuel tanks for a short period of time. Danny Ledger, son of Ray Ledger, the founder of Power Cat Boats, told me that they had so many problems they stopped making them. Especially today with 10% ethanol fuel, the fiberglass tanks would not hold up. Unfortunately the 18DC had them, and they still had fuel, and probably water, and oil in them. They absolutely reeked. Some people suggested I de-fuel them, then cut them open and insert standard fuel tanks. I chose to remove them from the boat for several reasons, mainly because I have to install a new transom. They had to come out to give me access to the transom from inside the boat so I could free it from the top to split the boat. I also didn't think I could successfully eliminate the smell, nor did I want to lose all that space under the splash well. I used a Japanese pull saw to carefully cut the fiberglass cloth that held the tanks in place and removed them from the boat.

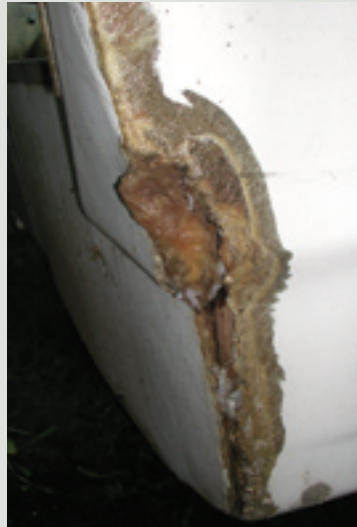
Finally, and this is the hard part of top removal, the splash well had to be broken free from the transom. There is no easy way to do this as these boats weren't originally built with the idea that 40 to 50 years hence anyone would be interested in restoring them. For the 18DC I found it easiest to cut off the fiberglass on the top of the transom as this then gave me good access to the plywood resin joint. It takes brute force, saws, and wedges, and more to break an 8-foot-long, 6-inch-wide, fiberglass resin joint. But once broken, the top was free of the bottom.

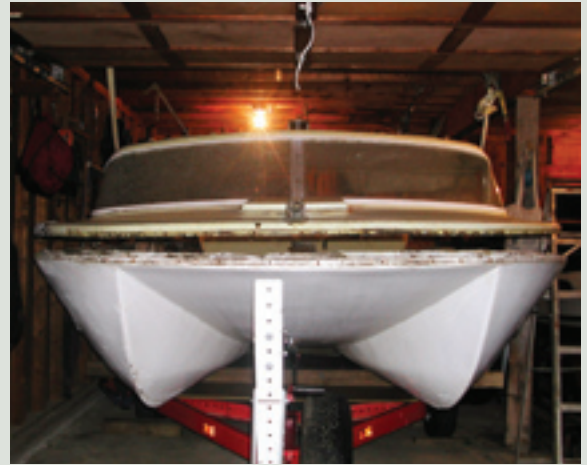
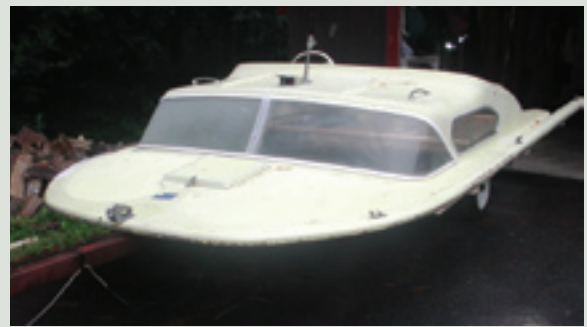
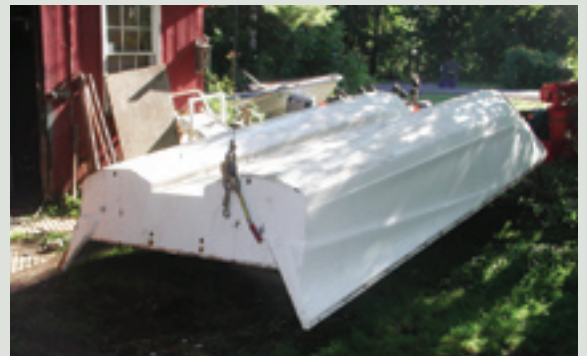
Starboard transom corner; note the transom's core is showing. Popping off the top—just like Tupperware®. Instantly you double the necessary floor space. You need to plan ahead. This boat has a true catamaran hull...and it's huge! Note the come-alongs attached to aerial steel wire. Below: a collage of fiberglass repair materials.

The transom I knew had to be replaced because of the split at the starboard corner. In addition, though not rotten, the 1 1/2" thick plywood core was very wet and portions were getting soft, so it had to go. Because most fiberglass boats are built in two pieces—the hull and a top—in order to replace a transom core usually the boat needs to be split in two. This is pretty much like taking the cover off a Tupperware® container. The top is built to fit over the hull and is fastened with staples, screws, rivets, bolts, and/or fiberglass. Rub rail is installed over the joint to hide it.

The next step was to lift the top off. Instantly you go from 128 square feet of space to twice that. You need to plan ahead where you're going to land the hull and top, and you especially need to plan to properly support the top since without the hull the top has little rigidity. I built a 2x4 frame, 8' wide by 12' long on a flat bed trailer. This provided mobility once the top was off. I placed the boat and the trailer in our garage, and then used a pair of come-alongs and lifting straps to remove the top from the hull. One strap was inserted through the side windows, and the second was inserted through the fuel fill holes. I used the come-alongs to lift the top straight up, keeping it even. Then I pulled the hull and trailer out of the garage leaving the top suspended. I backed the flatbed trailer into the garage and the top was lowered onto the frame. I took the top to the shop driveway and placed it on a work rack with the 2x4 frame. Then I brought the hull into the shop and off-loaded it onto the ground. Using a steel wire suspended 15' overhead together with come-alongs I lifted the hull and it rolled over, and placed it on a work rack. Sounds easy, but is not for the faint hearted.

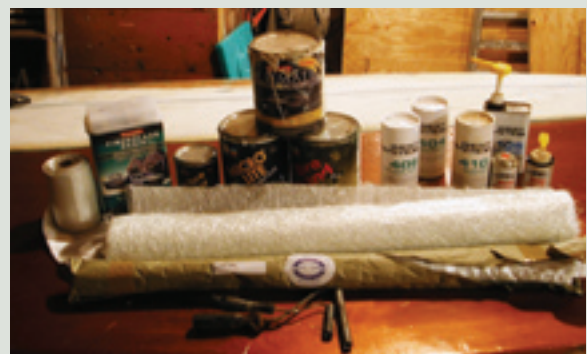
The collage photo shows some of the products one I use in fiberglass repair projects. Next time I'll chronicle fiberglass repairs and finishing of the boat.

For strong repairs like transom installations I use what is called MAT. MAT is randomly arrayed long fiber strands, so when set up it is strong in any direction. Woven cloth, also available in different weights, is used for finishing work and is typically the very first layer under a boat's gelcoat. You'll see this material used on many kit boats, kayaks, and canoes. When laid on properly the cloth is invisible in the resin. And finally there is woven roving. This is woven material, but a much heavier material than cloth, again available in different weights. Roving is used to provide structural strength and rigidity to a project, and then finished with MAT and lighter cloth. There are other specially materials like carbon fiber, Kevlar, and Dynel that I won't go into.
