Power Cat Redux... by Frank Alguire

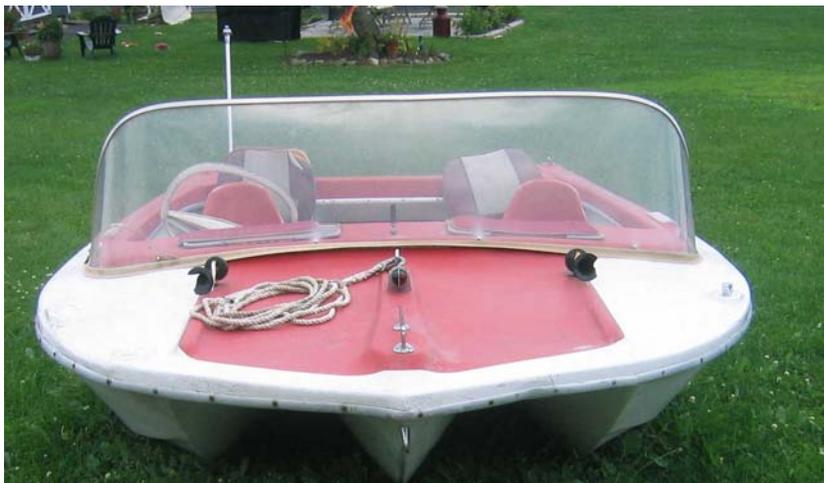
When I got home I posted pictures of the boat sitting in the lawn on the main forum of fiberglass.com and somebody replied "I think that's a Power Cat. If it is you should grab it!" So back I went to this guy's place to inquire about his lawn ornament. Turned out it was a Power Cat, and low and behold, he had the transferable registration for it. For some reason the

Power Cat side emblems had been removed and he had those along with the manufacturer's identification tag in a little zip lock bag. It was smashed and poorly repaired in the starboard bow, and obviously needed a new transom. He wanted \$200 for it. I didn't even try to haggle him down.

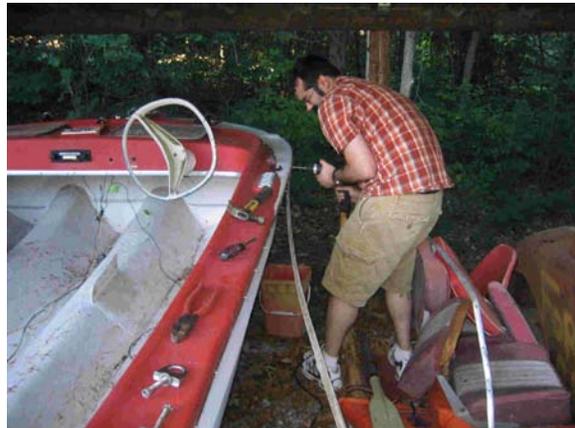
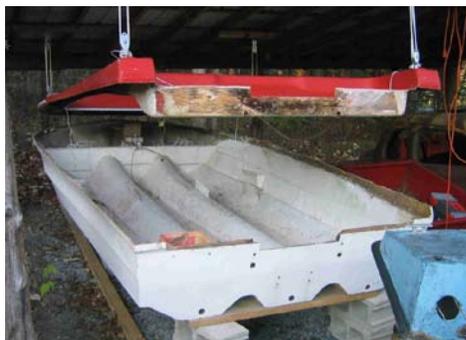
First I needed a place to work. The deck needed to be split from the hull to not only repair the damaged starboard bow area, but the transom was "toast." It ended up in half of my 12X20 unsided lean-to pole barn. Here you see my oldest son Gregg drilling out rivets in the rub rail because my left shoulder was in a sling.

It took a number of tools to finally separate the deck from the hull. For the most part, it was an old 3/4" wood chisel and a 16oz hammer, and a couple of big pry bars. With the use of block pulleys from the rafters of the pole barn putting constant strain on the seam, we were finally able to get the deck lifted. I had professional assistance separating the deck from the hull at the transom by Brian Lawson, owner of Classic Boat Works of Albany (NY) and who lives close by.

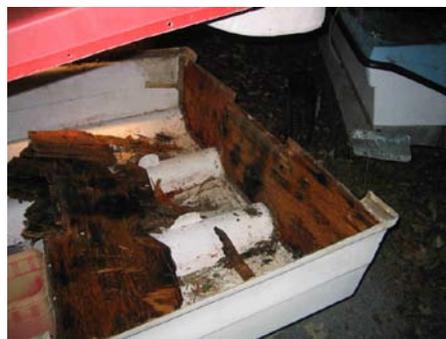
The transom was toast...

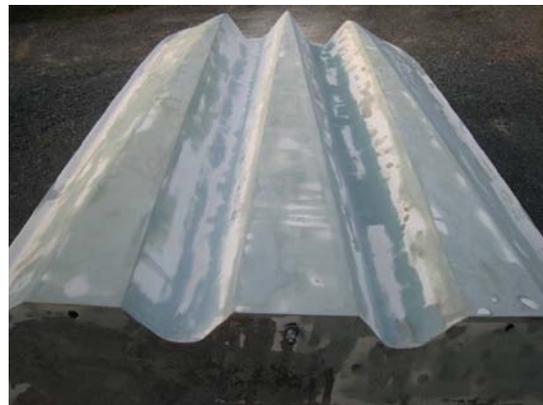
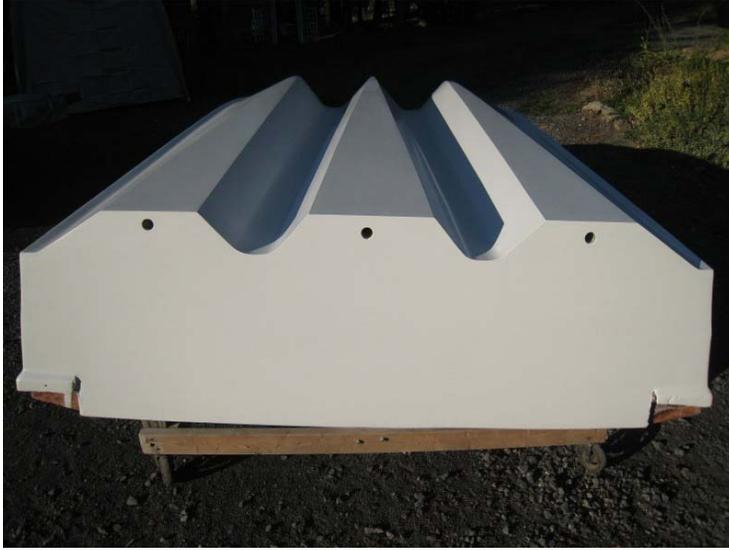
With that done, the hull could be flipped for work on the exterior. There were substantial gel coat cracks all over it.

It took most of 2008 to get this hull done, mostly due to health problems. The hull was blueprinted in restoration. Basically that meant perfectly flat sponsons, sharp edges on the sides of the sponsons and where the sponsons met the transom. With the hull done, work turned to the trailer. That needed to be done so I could easily move the project around. Those little casters on the hull stand didn't do so well in our gravel driveway.

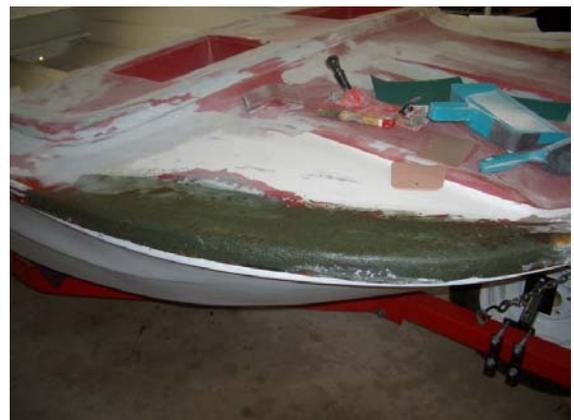
With the splash pan completed, attention turned to the deck. The deck had numerous cracks and spider webbing that all got ground out, then filled. This picture shows the major rebuild of the starboard bow. A similar rebuild had been done on that area of the hull earlier.

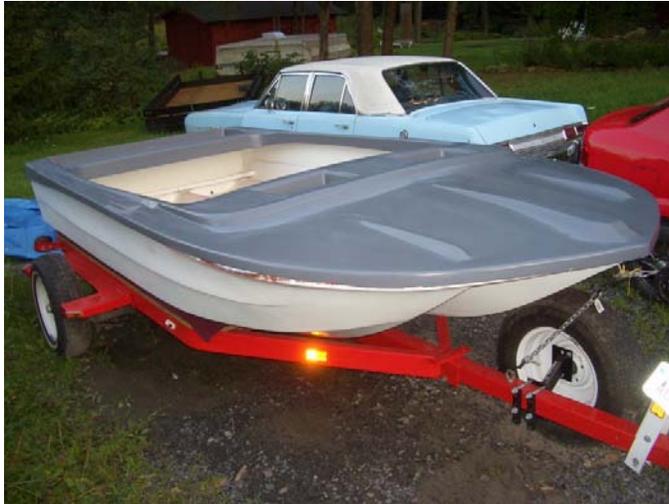
Finally the deck was done and in primer the summer of 2009. Towards the end of the summer health issues again surfaced, putting off more work on the boat for a few months.

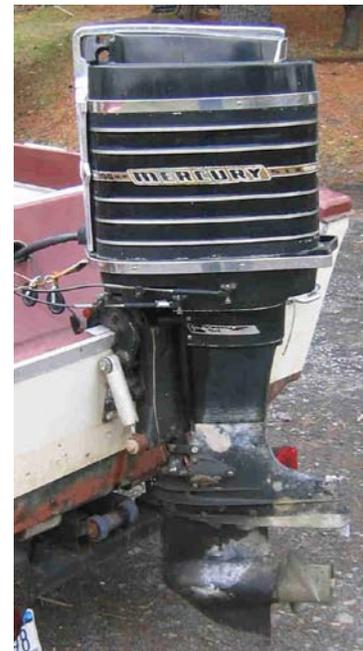
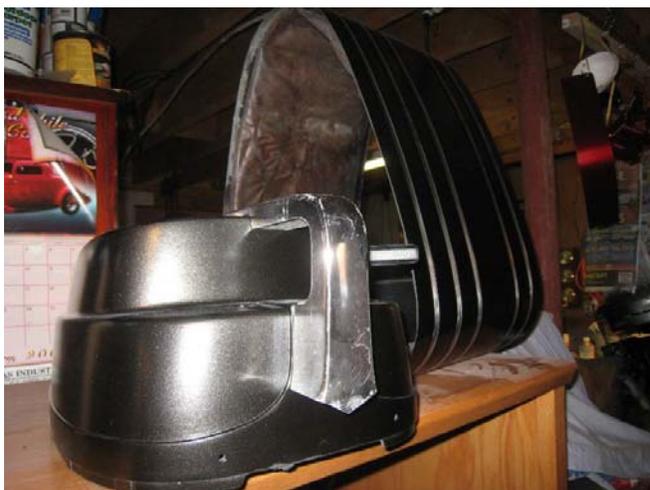
The fall of 2009, the year before initial launch, the motor got "pretty." It took a lot of time, but once one thing looked new, there would be something next to it that needed it. Pretty soon the entire motor had been painted inside and out, most with color than clear coat. It wasn't painted stock. Instead of using Mercury Phantom black, I used all metallic colors, black, red, and silver.

In winter 2010 I re-wired some of the motor, removed the stock rectifier and replaced it with a voltage regulator, and added in a circuit breaker for basic protection.

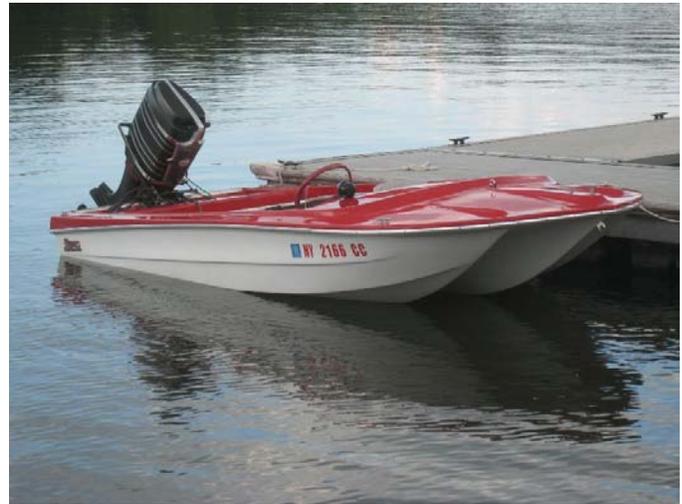
In the meantime, my wife was not enthused with the inexpensive folding seats I bought at WalMart. She went shopping and got the seats she thought belonged in our boat. I think she did great. Here the seats were mounted above the hulls. Later on, I built seat bases that lowered the bucket seats down into the hull as far as they would go. It looked much better and I didn't feel like we were top heavy out in the boat. You can also see in this picture the outboard tachometer I installed in the center of the dash. A tachometer is necessary to get the boat propped correctly.

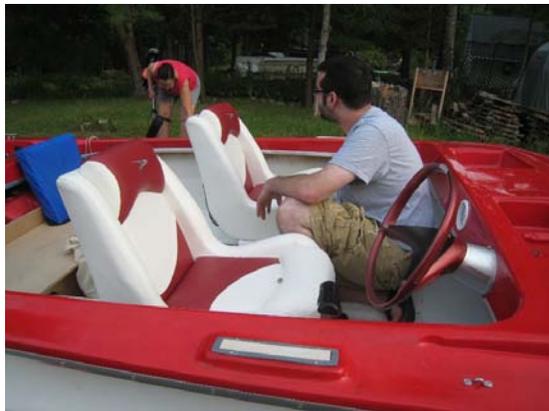
It took a lot of time and money before we found the right prop for the boat. Initially I had too much pitch, was not getting to the rpm's I needed. Plus we had way too much porpoising. Also, we couldn't take passengers. Two was the max. Finally, after installing Smart Tabs to assist in controlling porpoising, we ended up with a stainless steel three blade cupped prop in a pitch that made this old boat fly without porpoising. Now we could actually take passengers and the boat worked the way it was supposed to
